No. 1446143.8

SAMPLE DESCRIPTION:
LVT Primero II range flooring plank samples fixed to a clear Perspex base using:
- Uzin 888 Cementitious feather finish and absorbent mat used to prepare Perspex to receive plank.
- KE 66 wet-set dispersion-based (hard set).

ISO 4760:2022(E) - LAMINATE FLOORING – TOPICAL MOISTURE RESISTANCE – ASSEMBLED JOINT (MODIFIED)

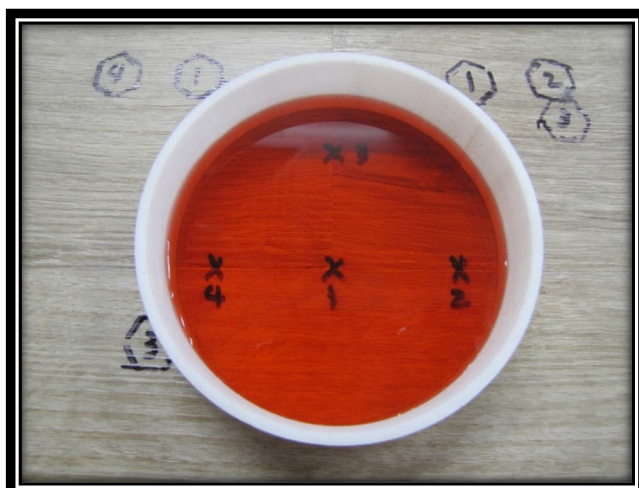
24 Hrs with Water

100 mls of dye solution was applied onto the sample surface. It was poured into a cylinder 100mm diameter placed in the centre of the sample at the "T joint." Sealant was used at the plank/cylinder interface to avoid leakage.

The underside of the sample was inspected through the clear Perspex to enable detection of any dye penetration through the sample.
