No. 1429920.0

SAMPLE DESCRIPTION:
 LVT flooring samples glued down to Perspex base using
 UZIN KE 68 T adhesive.
 Range – Amtico First
 Colour – Trent Oak SF3W2777

ISO 4760:2022(E) - LAMINATE FLOORING – TOPICAL MOISTURE RESISTANCE – ASSEMBLED JOINT (MODIFIED)

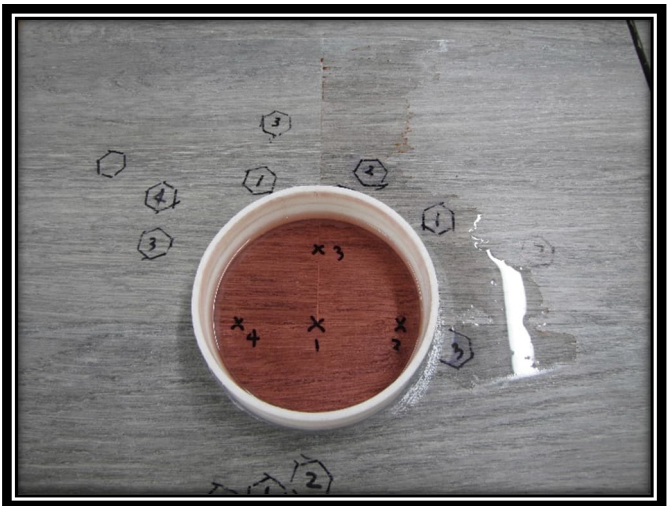
Water was able to channel through the joints and puddle on the surface of the planks.

Wet Swell		
	Specimen 1	Specimen 2	Specimen 3
Observations:	Water was able to channel through the joints and puddle on the surface of the planks. There was water left inside the ring. No water penetration to the underside of the planks through the joints.	No evidence of water penetrating the underside of the flooring planks through the joints.	No evidence of water penetrating the underside of the flooring planks through the joints.

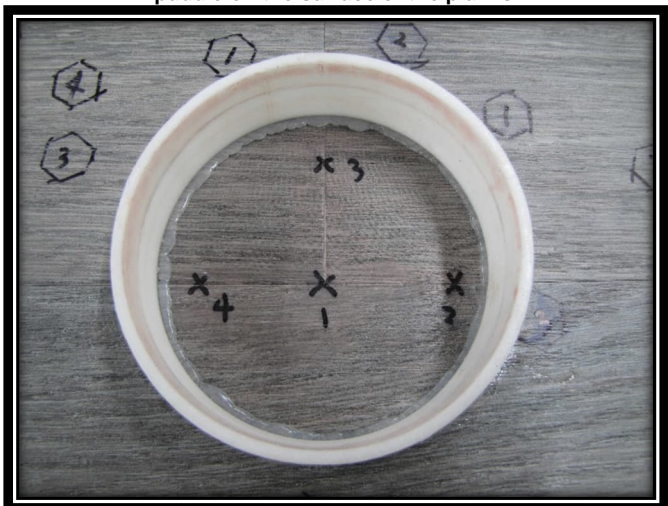
Recovered Swell

Recovered Swell		
	Specimen 1	Specimen 2	Specimen 3
Observations:	No evidence of water penetrating the underside of the flooring planks through the joints.	No evidence of water penetrating the underside of the flooring planks through the joints.	No evidence of water penetrating the underside of the flooring planks through the joints.
