CLIENT:  
Belgotex  
25 Leslie Hills Drive  
Riccarton, Christchurch

SAMPLE DESCRIPTION:  
Bjelin S/M/L assembly flooring  
9.2mm Harden timber.

## ISO 4760:2022(E) - LAMINATE FLOORING – TOPICAL MOISTURE RESISTANCE – ASSEMBLED JOINT (MODIFIED)

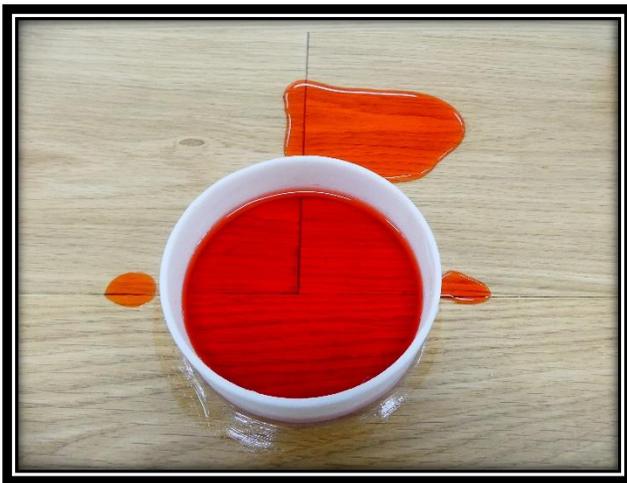
After 24 hrs With Water

100 mls of dye solution was applied onto the sample surface. It was poured into a cylinder 100mm diameter placed in the centre of the sample at the "T joint." Sealant was used at the plank/cylinder interface to avoid leakage.

Observations:	Specimen 1	Specimen 2	Specimen 3
Migration of water along the upper surface:	Yes	Yes	Yes
Migration of water to the underside:	No	No	No

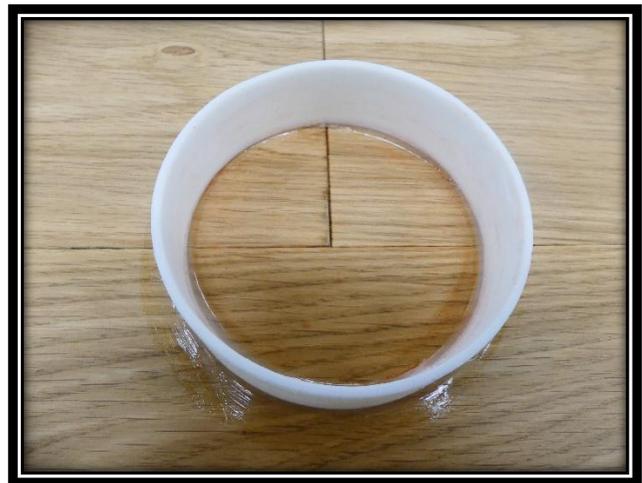
Wet Swell

Wet Swell			Recovered Swell		
	Specimen 1	Specimen 2	Specimen 3	Specimen 1	Specimen 2	Specimen 3
Qualitative Ratings (individual results):	2	2	2	1	1	1

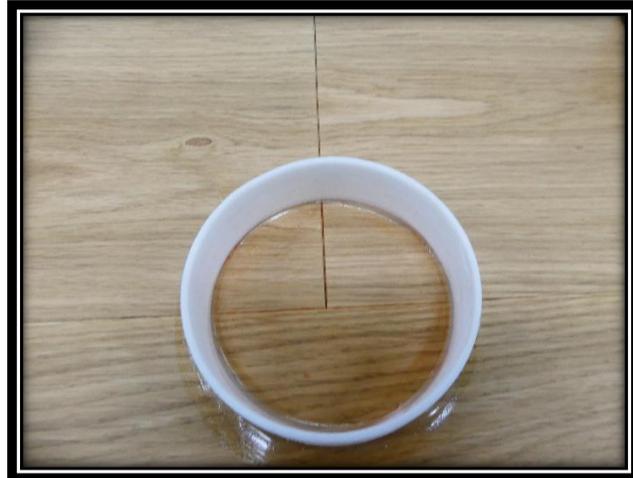
Recovered Swell

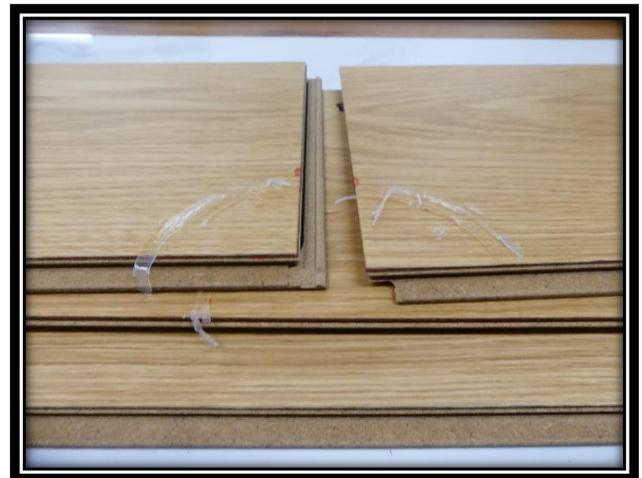
Recovered Swell (Disassembled)

Disassembly Observations:	Specimen 1	Specimen 2	Specimen 3
Migration of water along the upper surface:	Yes	Yes	Yes
Migration of water to the underside:	No	No	No
