No. 1428488.9

SAMPLE DESCRIPTION:
Laminate Flooring – Coventry
Nominal Size – 222.25mm x 1517.65mm
Nominal Wearlayer Thickness – 0.55mm
Backing – 1.55mm Acoustic Backing

ISO 4760:2022(E) - LAMINATE FLOORING – TOPICAL MOISTURE RESISTANCE – ASSEMBLED JOINT (MODIFIED)

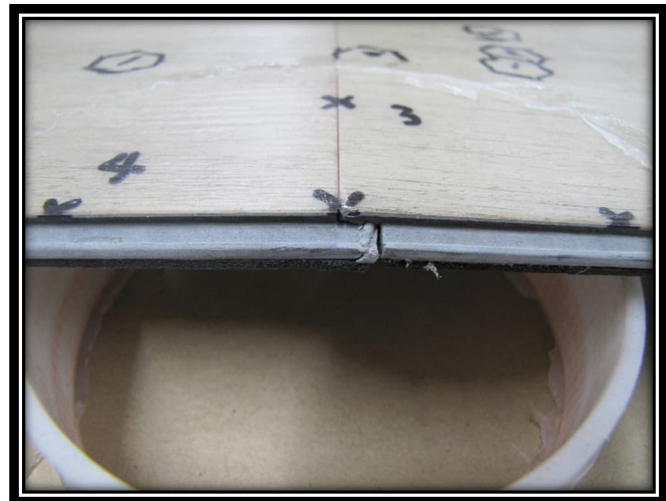
Recovered Swell (Disassembled)

Recovered Swell		
	Specimen 1	Specimen 2	Specimen 3
Disassembly Observations:	No water penetrated to the underside of the planks through the joints.	No water penetrated to the underside of the planks through the joints.	No water penetrated to the underside of the planks through the joints.
