SAMPLE DESCRIPTION:
BJELIN engineered timber planks assembly with PVA cross-linking glue applied in the joints.
Dimension – 2200x182x14.5mm
Range – 1-Strip
Model – Mix
Join system – Valinge 5G/2G

RESILIENT FLOOR COVERINGS (BASED ON ISO 4760:2022(E) - LAMINATE FLOORING – TOPICAL MOISTURE RESISTANCE – ASSEMBLED JOINT (MODIFIED))

No. 1524861.0

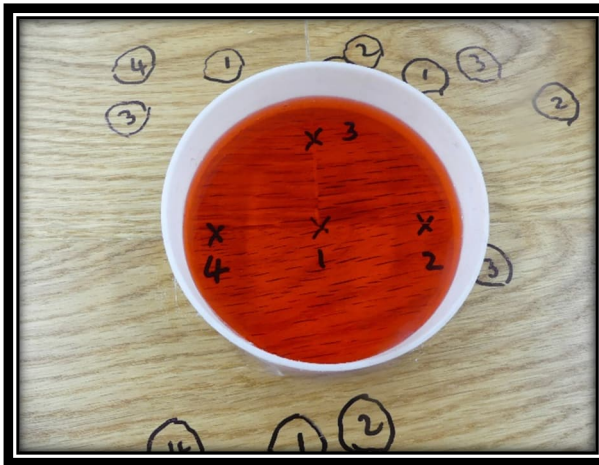
After 24 hrs With Water

100 mls of dye solution was applied onto the sample surface. It was poured into a cylinder 100mm diameter placed in the centre of the sample at the "T joint." Sealant was used at the plank/cylinder interface to avoid leakage.

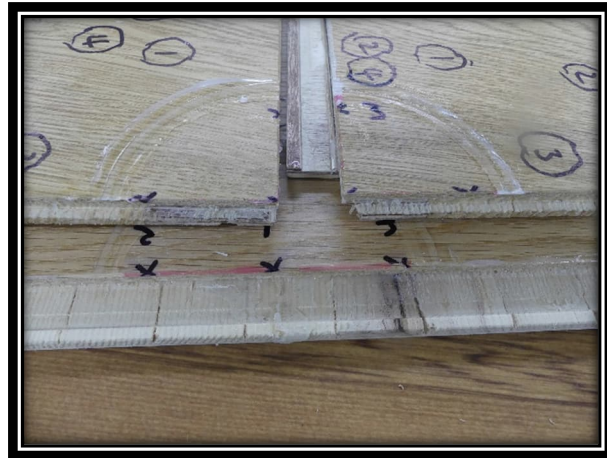
Recovered Swell (Disassembled)

Disassembly Observations:	Specimen 1	Specimen 2	Specimen 3
Migration of water along the upper surface:	No	No	No
Migration of water to the underside:	No	No	No
