CLIENT:
Belgotex
25 Leslie Hills Drive
Riccarton, Christchurch

SAMPLE DESCRIPTION:
BJELIN Engineered Timber planks assembly adhered to a clear Perspex using Mapie Ultrabond-eco-s995-1k.
Dimension – 2200x182x14.5
Range – 1-Strip
Model – Mix
Join System – Valinge 5G/2G

RESILIENT FLOOR COVERINGS (BASED ON ISO 4760:2022(E) - LAMINATE FLOORING – TOPICAL MOISTURE RESISTANCE – ASSEMBLED JOINT (MODIFIED))

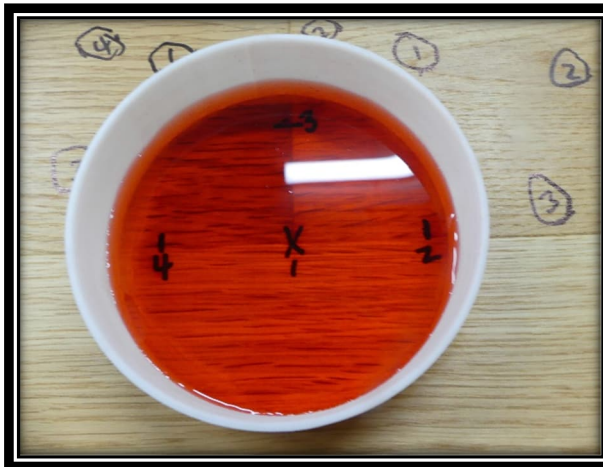
After 24 hrs With Water

Weights were placed on the outer corners of the test specimens to keep the samples flat throughout the test procedure. 100 mls of dye solution was applied onto the sample surface. It was poured into a cylinder 100mm diameter placed in the centre of the sample at the "T joint." Sealant was used at the plank/cylinder interface to avoid leakage.

The sample was placed on white paper towels prior to testing to enable detection of any dye penetration through the joints. The sample was left at 20°C, 65% Relative Humidity room conditions for 24 hours after the dye was added and then examined for dye penetration through the backing (not 23°C, 50% RH as stated in the method).

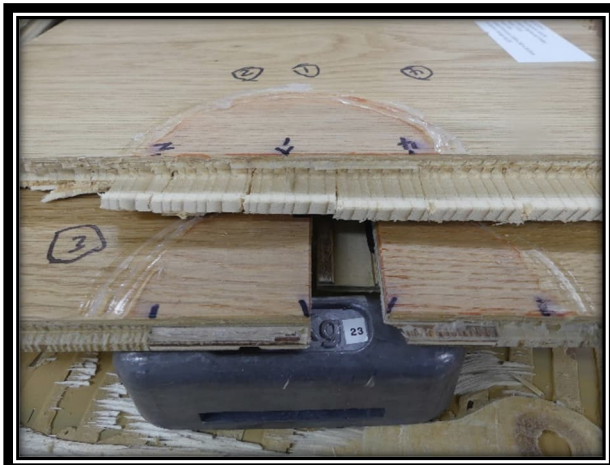
Recovered Swell (Disassembled)

Disassembly Observations:	Specimen 1	Specimen 2	Specimen 3
Migration of water along the upper surface:	No	No	No
Migration of water to the underside:	No	No	No
