CLIENT:  
Belgotex  
25 Leslie Hills Drive  
Riccarton, Christchurch

SAMPLE DESCRIPTION:  
Bjelin L European hardened timber flooring planks  
assembly fixed to a clear Perspex base using Mapie  
Ultrabond Eco 995 adhesive.

## RESILIENT FLOOR COVERINGS (BASED ON ISO 4760:2022(E) - LAMINATE FLOORING – TOPICAL MOISTURE RESISTANCE – ASSEMBLED JOINT (MODIFIED))

**No. 1550886.4**

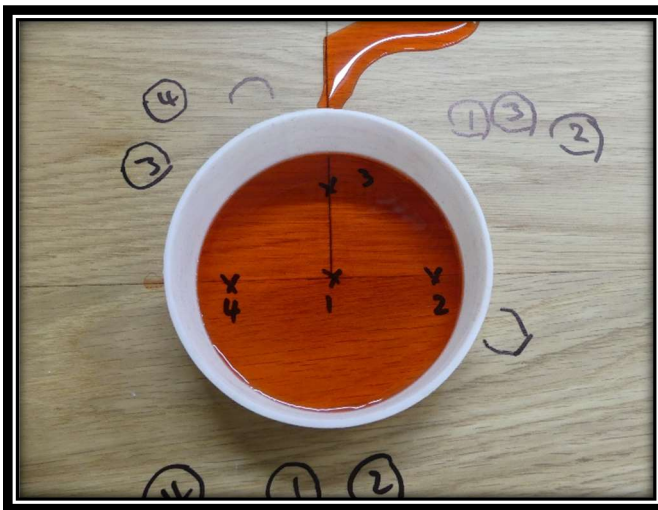
100 mls of dye solution was applied onto the sample surface. It was poured into a cylinder 100mm diameter placed in the centre of the sample at the "T joint." Sealant was used at the plank/cylinder interface to avoid leakage.

The underside of the sample was inspected through the clear Perspex to enable detection of any dye penetration through the sample.

24 Hrs with Water

Observations:	Specimen 1	Specimen 2	Specimen 3
Migration of water along the upper surface:	Yes	Yes	Yes
Migration of water to the underside:	No	No	No

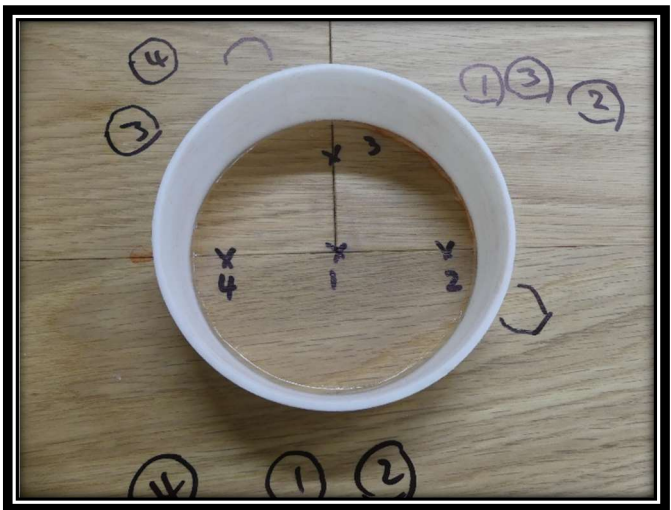
Quantitative measurements are used to calculate surface swell in mm (within 15 minutes after water removal) and recovery swell (24 hours after removal of water).

Wet Swell

Quantitative Results:	Wet Swell (mm)			Recovered Swell (mm)		
	Specimen 1	Specimen 2	Specimen 3	Specimen 1	Specimen 2	Specimen 3
Final Average Results (Positions 2 to 4)	0.03	0.02	0.04	0.05	0.05	0.04
Final Results (Position 1)	0.01	0.00	0.08	0.02	0.00	0.05

Wet Swell			Recovered Swell		
	Specimen 1	Specimen 2	Specimen 3	Specimen 1	Specimen 2	Specimen 3
Qualitative Ratings (individual results):	1	1	1	1	1	1

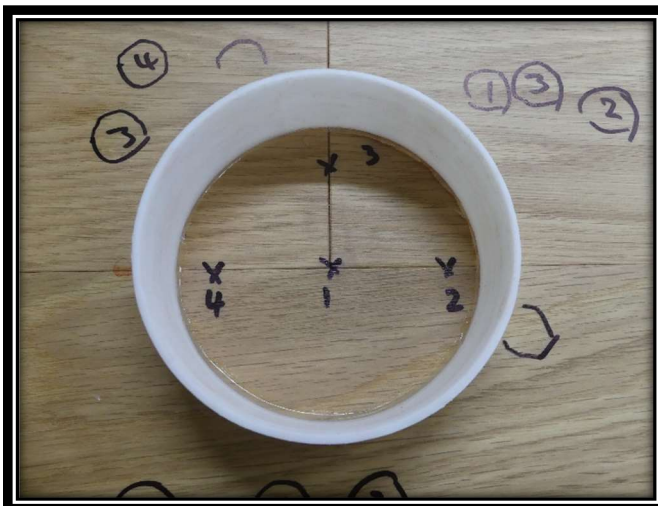
Recovered Swell

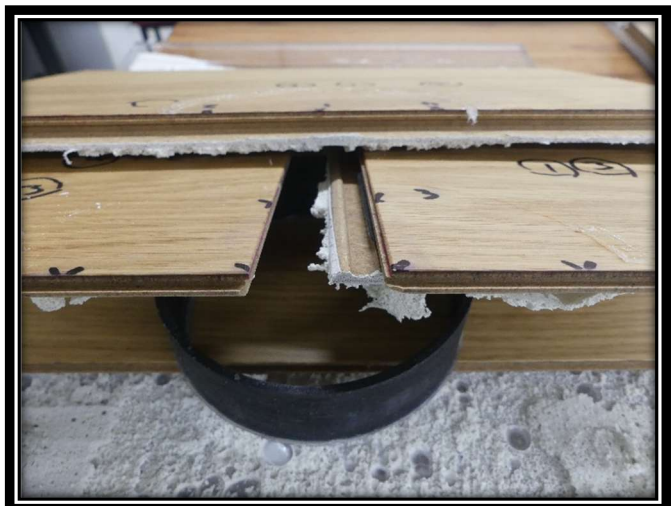
Recovered Swell (Disassembled)

Disassembly Observations:	Specimen 1	Specimen 2	Specimen 3
Migration of water along the upper surface:	No	No	Yes
Migration of water to the underside:	No	No	No
