CLIENT:
Belgotex
25 Leslie Hills Drive
Riccarton, Christchurch

SAMPLE DESCRIPTION:
BJELIN hardened timber planks assembly with PVA cross-linking glue applied in the joints.
Dimension – 2000x180x9.2mm
Range – Woodura
Model – Large & Small
Join system – Valinge 5G Dry

RESILIENT FLOOR COVERINGS (BASED ON ISO 4760:2022(E) - LAMINATE FLOORING – TOPICAL MOISTURE RESISTANCE – ASSEMBLED JOINT (MODIFIED))

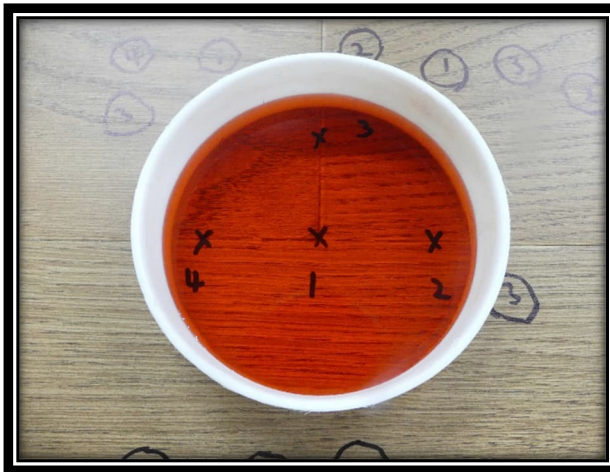
After 24 hrs With Water

100 mls of dye solution was applied onto the sample surface. It was poured into a cylinder 100mm diameter placed in the centre of the sample at the "T joint." Sealant was used at the plank/cylinder interface to avoid leakage.

The sample was left at 20°C, 65% Relative Humidity room conditions for 24 hours after the dye was added and then examined for dye penetration through the backing (not 23°C, 50% RH as stated in the method).

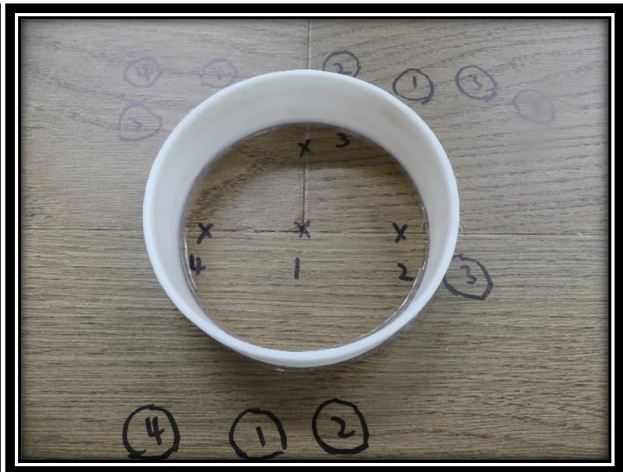
Wet Swell

Quantitative Results:	Wet Swell (mm)			Recovered Swell (mm)		
	Specimen 1	Specimen 2	Specimen 3	Specimen 1	Specimen 2	Specimen 3
Final Average Results (Positions 2 to 4)	0.05	0.17	0.18	0.08	0.07	0.09
Final Results (Position 1)	0.10	0.18	0.19	0.06	0.16	0.16
