SAMPLE DESCRIPTION:  
Kahrs hardened timber planks assembly adhered to a clear Perspex using Mapei Ultrabond-eco-s995-1k.  
Dimension – 1225x118x7mm  
Range – Life  
Model – Narrow  
Join System – Valinge 5G

## RESILIENT FLOOR COVERINGS (BASED ON ISO 4760:2022(E) - LAMINATE FLOORING – TOPICAL MOISTURE RESISTANCE – ASSEMBLED JOINT (MODIFIED))

**No. 1524857.8**

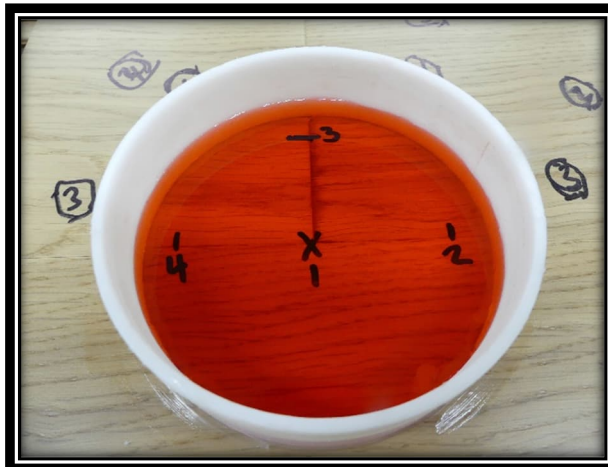
After 24 hrs With Water

Observations:	Specimen 1	Specimen 2	Specimen 3
Migration of water along the upper surface:	No	No	No
Migration of water to the underside:	No	No	No

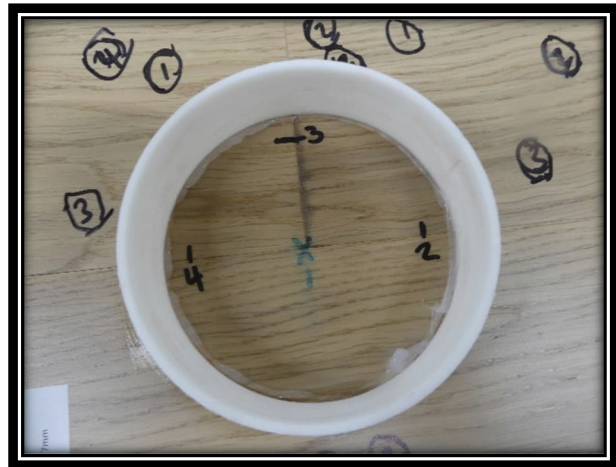
Wet Swell

Quantitative Results:	Wet Swell (mm)			Recovered Swell (mm)		
	Specimen 1	Specimen 2	Specimen 3	Specimen 1	Specimen 2	Specimen 3
Final Average Results (Positions 2 to 4)	0.08	0.00	0.03	0.07	0.09	0.04
Final Results (Position 1)	0.18	0.29	0.06	0.08	0.22	0.60

Wet Swell			Recovered Swell		
	Specimen 1	Specimen 2	Specimen 3	Specimen 1	Specimen 2	Specimen 3
Qualitative Ratings (individual results):	2	1	3	1	1	3

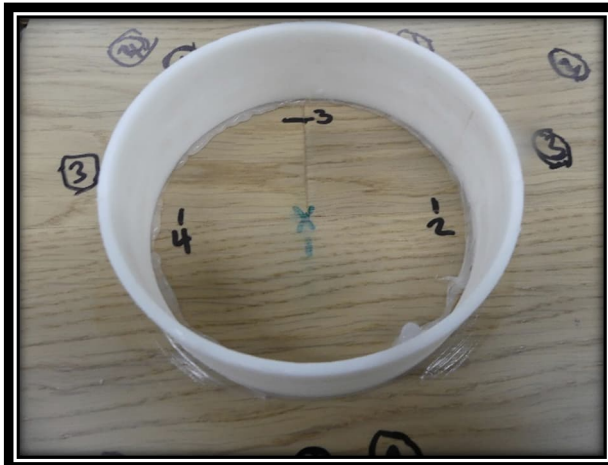
Recovered Swell

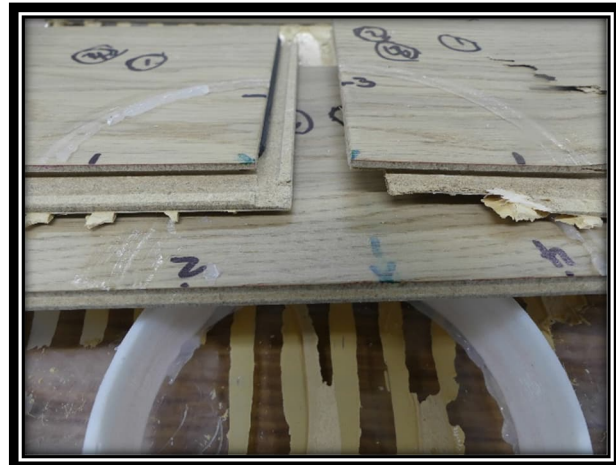
Recovered Swell (Disassembled)

Disassembly Observations:	Specimen 1	Specimen 2	Specimen 3
Migration of water along the upper surface:	No	No	No
Migration of water to the underside:	No	No	No
