SAMPLE DESCRIPTION:
Kahrs hardened timber planks assembly with PVA cross-linking glue applied in the joints.
Dimension – 1810x150x7mm
Range – Life
Model – Wide
Join system – Valinge 5G

RESILIENT FLOOR COVERINGS (BASED ON ISO 4760:2022(E) - LAMINATE FLOORING – TOPICAL MOISTURE RESISTANCE – ASSEMBLED JOINT (MODIFIED))

No. 1524864.4

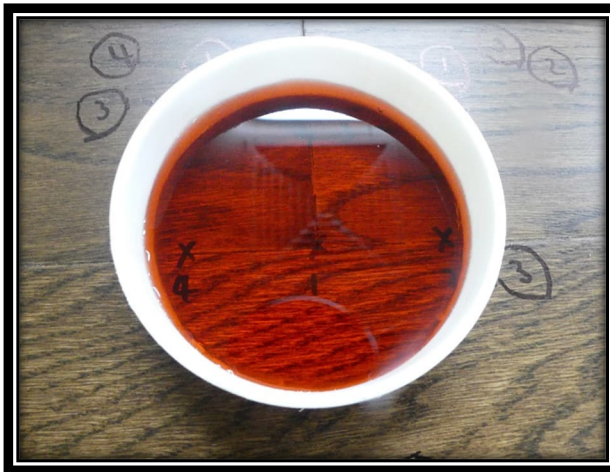
After 24 hrs With Water

100 mls of dye solution was applied onto the sample surface. It was poured into a cylinder 100mm diameter placed in the centre of the sample at the "T joint." Sealant was used at the plank/cylinder interface to avoid leakage.

The sample was placed on white paper towels prior to testing to enable detection of any dye penetration through the joints.

The sample was left at 20°C, 65% Relative Humidity room conditions for 24 hours after the dye was added and then examined for dye penetration through the backing (not 23°C, 50% RH as stated in the method).
