SAMPLE DESCRIPTION:
Kahrs hardened timber planks assembly adhered to a clear Perspex using Mapie Ultrabond-eco-s995-1k.
Dimension – 1810x150x7mm
Range – Life
Model – Wide
Join System – Valinge 5G

RESILIENT FLOOR COVERINGS (BASED ON ISO 4760:2022(E) - LAMINATE FLOORING – TOPICAL MOISTURE RESISTANCE – ASSEMBLED JOINT (MODIFIED))

No. 1524856.0

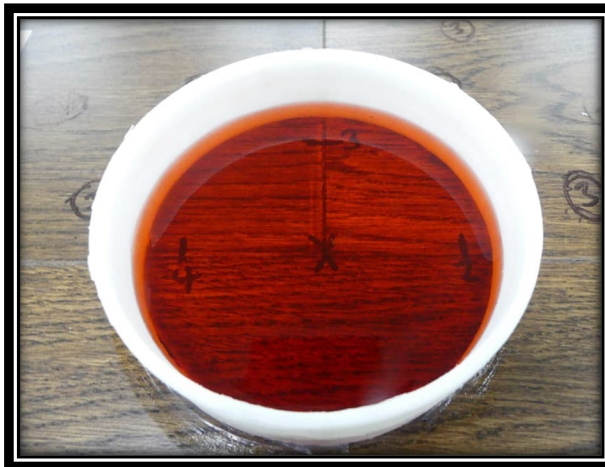
After 24 hrs With Water

100 mls of dye solution was applied onto the sample surface. It was poured into a cylinder 100mm diameter placed in the centre of the sample at the “T joint.” Sealant was used at the plank/cylinder interface to avoid leakage.

The sample was placed on white paper towels prior to testing to enable detection of any dye penetration through the joints. The sample was left at 20°C, 65% Relative Humidity room conditions for 24 hours after the dye was added and then examined for dye penetration through the backing (not 23°C, 50% RH as stated in the method).

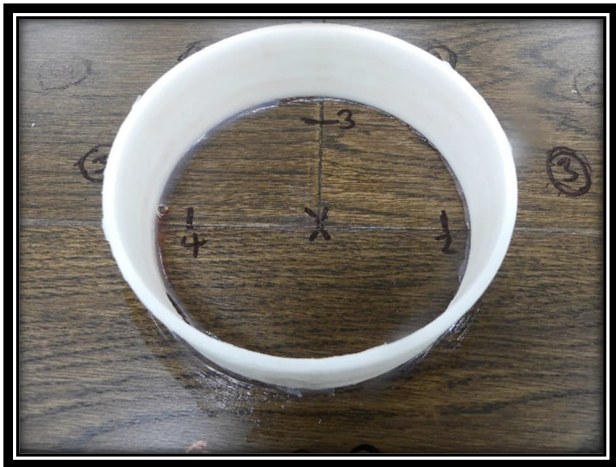
Wet Swell

Quantitative Results:	Wet Swell (mm)			Recovered Swell (mm)		
	Specimen 1	Specimen 2	Specimen 3	Specimen 1	Specimen 2	Specimen 3
Final Average Results (Positions 2 to 4)	0.08	0.44	0.18	0.04	0.17	0.16
Final Results (Position 1)	0.21	0.30	0.19	0.11	0.26	0.17

Wet Swell			Recovered Swell		
	Specimen 1	Specimen 2	Specimen 3	Specimen 1	Specimen 2	Specimen 3
Qualitative Ratings (individual results):	2	2	2	1	1	1

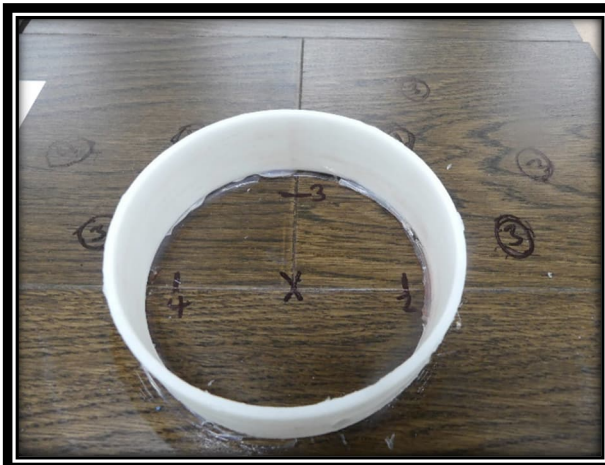
Recovered Swell

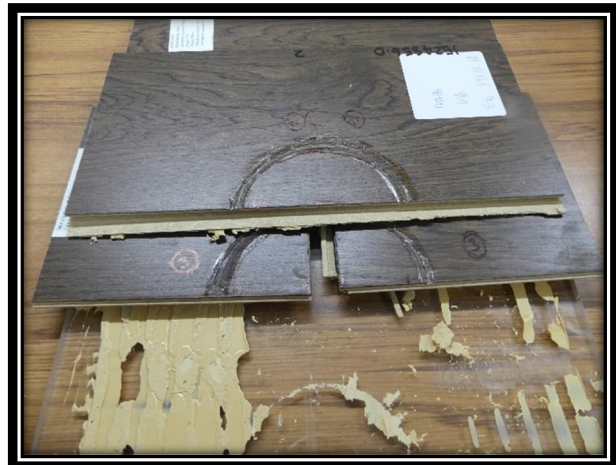
Recovered Swell (Disassembled)

Disassembly Observations:	Specimen 1	Specimen 2	Specimen 3
Migration of water along the upper surface:	No	No	No
Migration of water to the underside:	No	No	No
