CLIENT:
Belgotex
25 Leslie Hills Drive
Riccarton, Christchurch

SAMPLE DESCRIPTION:
Bjelin S European Hardened timber flooring planks
assembly fixed to a clear Perspex base using Mapie
Ultrabond Eco 995 adhesive.

RESILIENT FLOOR COVERINGS (BASED ON ISO 4760:2022(E) - LAMINATE FLOORING – TOPICAL MOISTURE RESISTANCE – ASSEMBLED JOINT (MODIFIED))

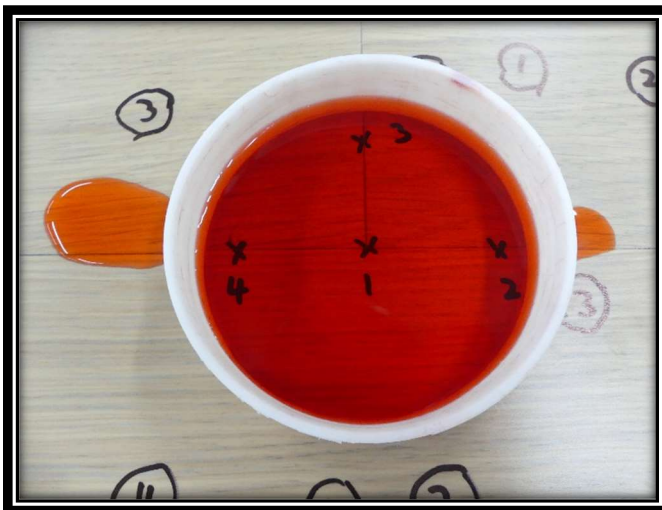
24 Hrs with Water

100 mls of dye solution was applied onto the sample surface. It was poured into a cylinder 100mm diameter placed in the centre of the sample at the "T joint." Sealant was used at the plank/cylinder interface to avoid leakage.

The underside of the sample was inspected through the clear Perspex to enable detection of any dye penetration through the sample.

The sample was left at 20°C, 65% Relative Humidity room conditions for 24 hours after the dye was added and then examined for dye penetration through the backing (not 23°C, 50% RH as stated in the method).

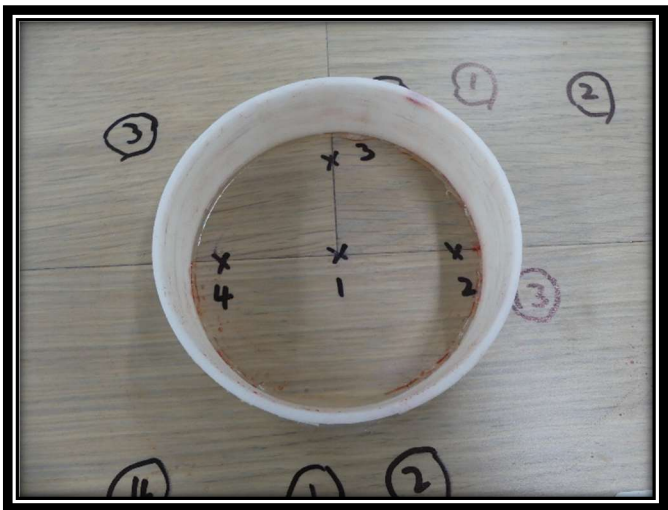
Wet Swell

Quantitative Results:	Wet Swell (mm)			Recovered Swell (mm)		
	Specimen 1	Specimen 2	Specimen 3	Specimen 1	Specimen 2	Specimen 3
Final Average Results (Positions 2 to 4)	0.01	0.00	0.01	0.00	0.03	0.00
Final Results (Position 1)	0.03	0.00	0.05	0.00	0.00	0.13

Wet Swell			Recovered Swell		
	Specimen 1	Specimen 2	Specimen 3	Specimen 1	Specimen 2	Specimen 3
Qualitative Ratings (individual results):	1	1	1	1	1	1
