SAMPLE DESCRIPTION:
BJELIN hardened timber planks assembly adhered to a clear Perspex using Mapie Ultrabond-eco-s995-1k.
Dimension – 2200x206x11.3mm
Range – Woodura
Model – XL
Join System – Valinge 5G Dry

RESILIENT FLOOR COVERINGS (BASED ON ISO 4760:2022(E) - LAMINATE FLOORING – TOPICAL MOISTURE RESISTANCE – ASSEMBLED JOINT (MODIFIED))

No. 1524854.5

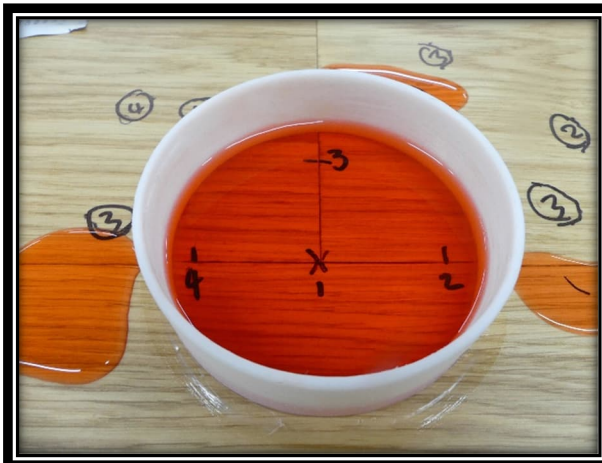
After 24 hrs With Water

Weights were placed on the outer corners of the test specimens to keep the samples flat throughout the test procedure. 100 mls of dye solution was applied onto the sample surface. It was poured into a cylinder 100mm diameter placed in the centre of the sample at the "T joint." Sealant was used at the plank/cylinder interface to avoid leakage.

Observations:	Specimen 1	Specimen 2	Specimen 3
Migration of water along the upper surface:	Yes	Yes	Yes
Migration of water to the underside:	No	No	No

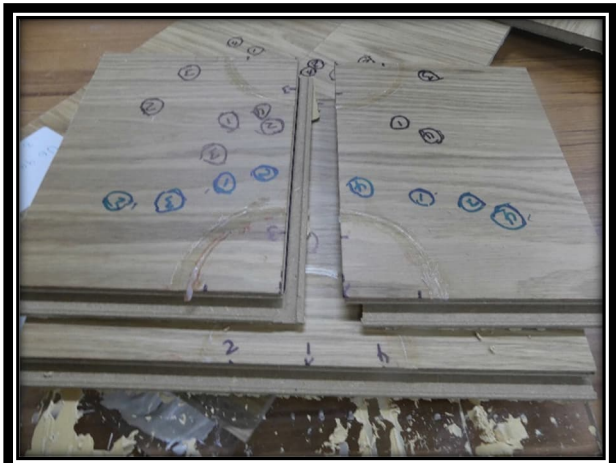
Recovered Swell (Disassembled)

Disassembly Observations:	Specimen 1	Specimen 2	Specimen 3
Migration of water along the upper surface:	No	No	No
Migration of water to the underside:	No	No	No
