SAMPLE DESCRIPTION:  
BOEN 181 & Castle 209 Live Pure (lacquered finish)  
engineered flooring planks assembly with PVA cross  
linking adhesive applied in the joints.

## RESILIENT FLOOR COVERINGS (BASED ON ISO 4760:2022(E) - LAMINATE FLOORING – TOPICAL MOISTURE RESISTANCE – ASSEMBLED JOINT (MODIFIED))

**No. 1535247.9**

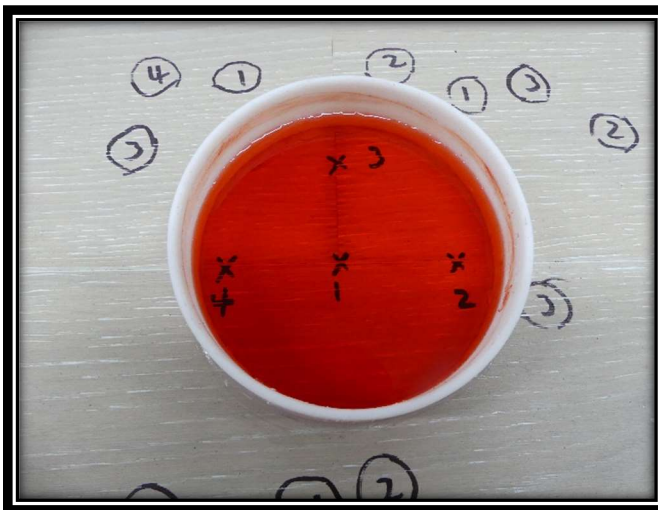
After 24 hrs With Water

100 mls of dye solution was applied onto the sample surface. It was poured into a cylinder 100mm diameter placed in the centre of the sample at the "T joint." Sealant was used at the plank/cylinder interface to avoid leakage.

Observations:	Specimen 1	Specimen 2	Specimen 3
Migration of water along the upper surface:	No	No	No
Migration of water to the underside:	No	No	No

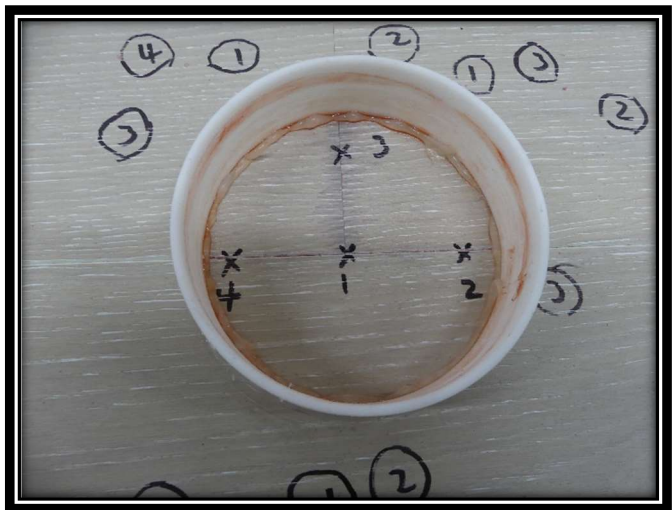
Wet Swell

Quantitative Results:	Wet Swell (mm)			Recovered Swell (mm)		
	Specimen 1	Specimen 2	Specimen 3	Specimen 1	Specimen 2	Specimen 3
Final Average Results (Positions 2 to 4)	0.16	0.06	0.21	0.09	0.08	0.19
Final Results (Position 1)	0.16	0.14	0.00	0.08	0.04	0.00

Wet Swell			Recovered Swell		
	Specimen 1	Specimen 2	Specimen 3	Specimen 1	Specimen 2	Specimen 3
Qualitative Ratings (individual results):	1	1	1	1	1	1

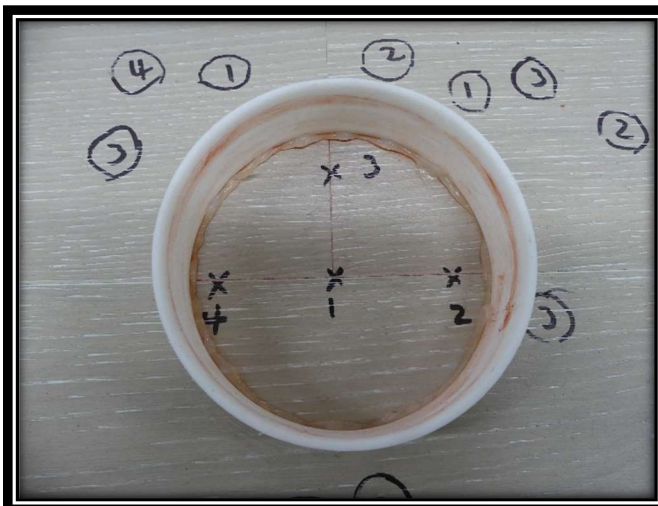
Recovered Swell

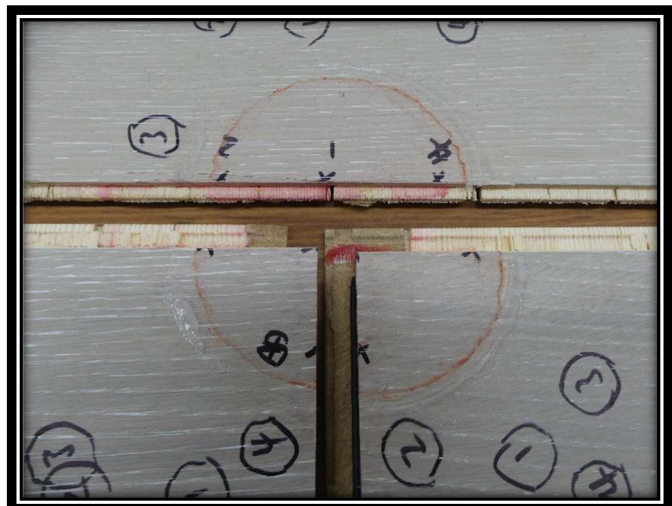
Recovered Swell (Disassembled)

Disassembly Observations:	Specimen 1	Specimen 2	Specimen 3
Migration of water along the upper surface:	No	No	Yes
Migration of water to the underside:	No	No	No
