SAMPLE DESCRIPTION:
BOEN engineered timber planks (Live Pure – lacquered
finish) assembly adhered to a clear Perspex using
Mapei Ultrabond-eco-s995-1k.
Dimension – 2200x181x13.2mm
Range – Plank 181 & Castle Plank 209
Model – Plank 181
Join System – Valinge 5G

RESILIENT FLOOR COVERINGS (BASED ON ISO 4760:2022(E) - LAMINATE FLOORING – TOPICAL MOISTURE RESISTANCE – ASSEMBLED JOINT (MODIFIED))

No. 1524858.6

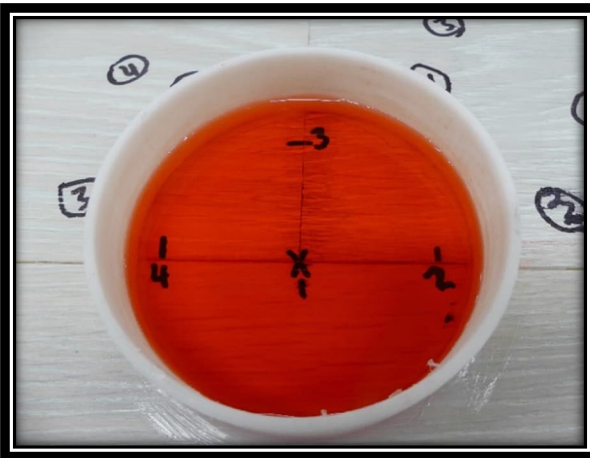
After 24 hrs With Water

100 mls of dye solution was applied onto the sample surface. It was poured into a cylinder 100mm diameter placed in the centre of the sample at the “T joint.” Sealant was used at the plank/cylinder interface to avoid leakage.

Observations:	Specimen 1	Specimen 2	Specimen 3
Migration of water along the upper surface:	No	No	No
Migration of water to the underside:	No	No	No

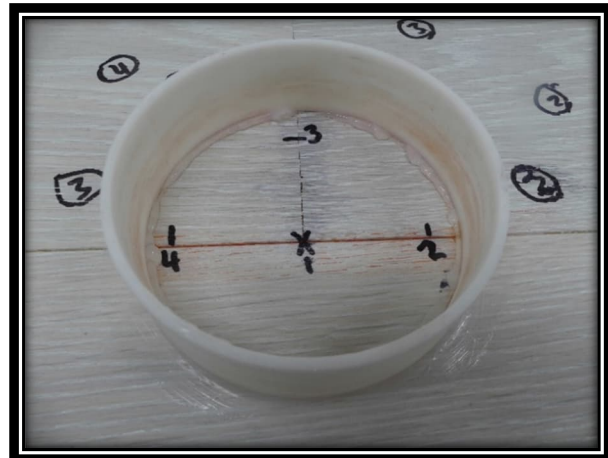
Wet Swell

Quantitative Results:	Wet Swell (mm)			Recovered Swell (mm)		
	Specimen 1	Specimen 2	Specimen 3	Specimen 1	Specimen 2	Specimen 3
Final Average Results (Positions 2 to 4)	0.12	0.08	0.19	0.05	0.09	0.15
Final Results (Position 1)	0.16	0.11	0.32	0.16	0.06	0.37

Wet Swell			Recovered Swell		
	Specimen 1	Specimen 2	Specimen 3	Specimen 1	Specimen 2	Specimen 3
Qualitative Ratings (individual results):	1	2	2	1	1	1

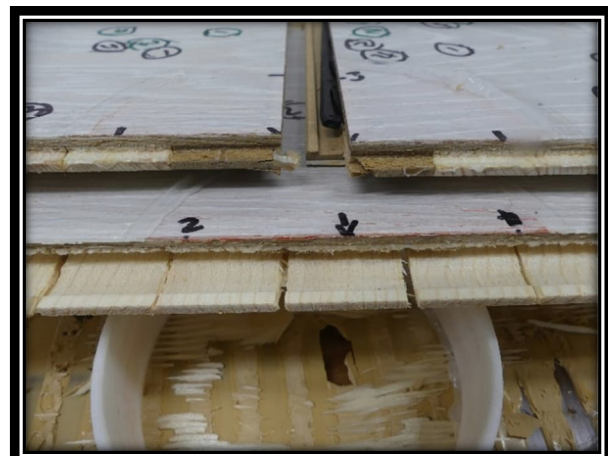
Recovered Swell (Disassembled)

Disassembly Observations:	Specimen 1	Specimen 2	Specimen 3
Migration of water along the upper surface:	No	No	Yes
Migration of water to the underside:	No	No	No
