CLIENT:  
Belgotex  
25 Leslie Hills Drive  
Riccarton, Christchurch

SAMPLE DESCRIPTION:  
Finfloor Purefloor laminate flooring planks assembly.  
with PVA cross linking glue applied in the joints.

## ISO 4760:2022(E) - LAMINATE FLOORING – TOPICAL MOISTURE RESISTANCE – ASSEMBLED JOINT (MODIFIED)

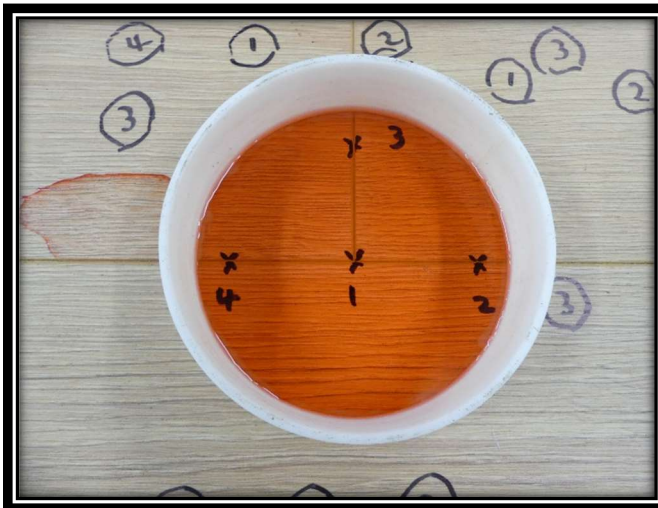
After 24 hrs With Water

100 mls of dye solution was applied onto the sample surface. It was poured into a cylinder 100mm diameter placed in the centre of the sample at the "T joint." Sealant was used at the plank/cylinder interface to avoid leakage.

The sample was left at 20°C, 65% Relative Humidity room conditions for 24 hours after the dye was added and then examined for dye penetration through the backing (not 23°C, 50% RH as stated in the method).

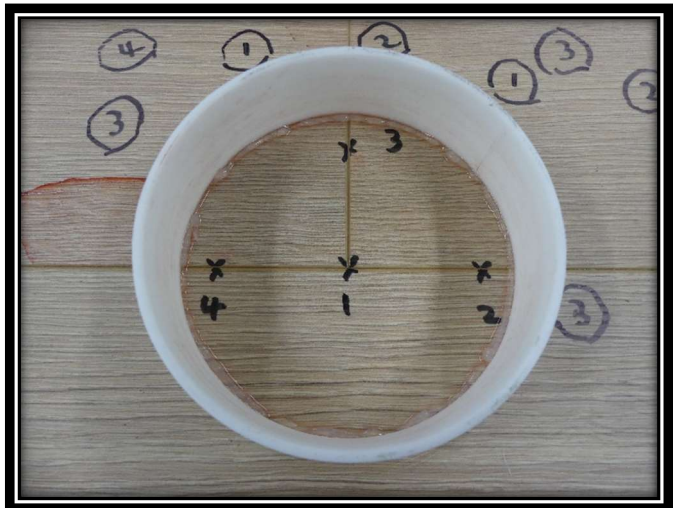
Wet Swell

Quantitative Results:	Wet Swell (mm)			Recovered Swell (mm)		
	Specimen 1	Specimen 2	Specimen 3	Specimen 1	Specimen 2	Specimen 3
Final Average Results (Positions 2 to 4)	0.49	0.71	0.49	0.57	0.74	0.55
Final Results (Position 1)	0.51	0.77	0.73	0.70	0.88	0.77

Wet Swell			Recovered Swell		
	Specimen 1	Specimen 2	Specimen 3	Specimen 1	Specimen 2	Specimen 3
Qualitative Ratings (individual results):	2	2	2	2	2	2

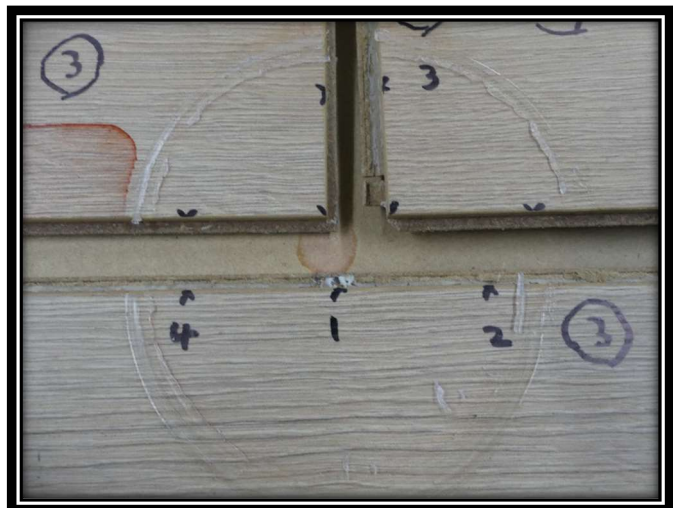
Recovered Swell (Disassembled)

Disassembly Observations:	Specimen 1	Specimen 2	Specimen 3
Migration of water along the upper surface:	Yes	Yes	Yes
Migration of water to the underside:	Yes	Yes	No
