CLIENT:
Belgotex
25 Leslie Hills Drive
Riccarton, Christchurch

SAMPLE DESCRIPTION:
Decospan hardened timber planks assembly with PVA cross-linking glue applied in the joints.
Dimension – 1810x166x10mm
Range – Parky
Model – Deluxe & Summit
Join system – Unifit-X

RESILIENT FLOOR COVERINGS (BASED ON ISO 4760:2022(E) - LAMINATE FLOORING – TOPICAL MOISTURE RESISTANCE – ASSEMBLED JOINT (MODIFIED))

No. 1524862.8

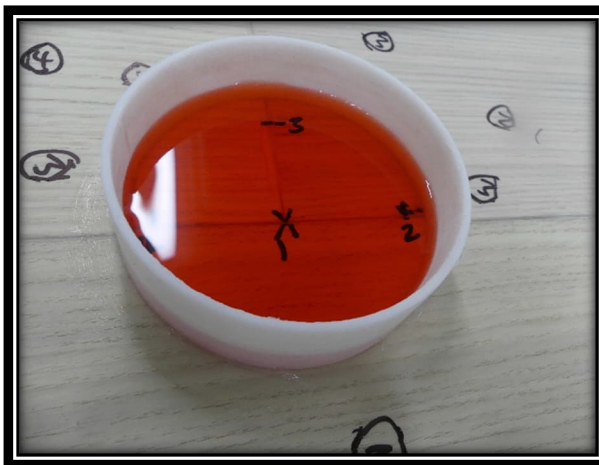
After 24 hrs With Water

100 mls of dye solution was applied onto the sample surface. It was poured into a cylinder 100mm diameter placed in the centre of the sample at the "T joint." Sealant was used at the plank/cylinder interface to avoid leakage.

The sample was left at 20°C, 65% Relative Humidity room conditions for 24 hours after the dye was added and then examined for dye penetration through the backing (not 23°C, 50% RH as stated in the method).

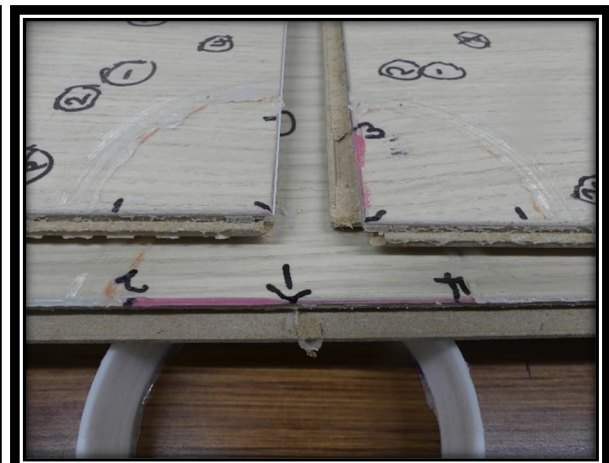
Recovered Swell (Disassembled)

Disassembly Observations:	Specimen 1	Specimen 2	Specimen 3
Migration of water along the upper surface:	No	No	No
Migration of water to the underside:	No	No	No
