No. 1429918.4

SAMPLE DESCRIPTION:
LVT Province range flooring plank samples fixed to a clear Perspex base using:
- Uzin 888 Cementitious feather finish and absorbent mat used to prepare Perspex to receive plank.
- KE 68 single compound hybrid/urethane adhesive.

ISO 4760:2022(E) - LAMINATE FLOORING – TOPICAL MOISTURE RESISTANCE – ASSEMBLED JOINT (MODIFIED)

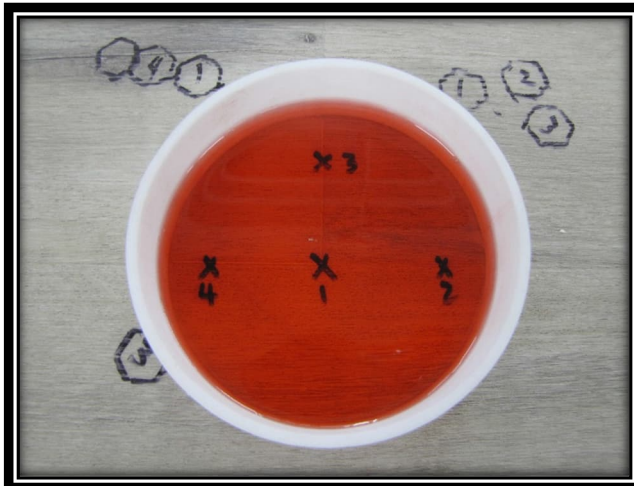
24 Hrs with Water

100 mls of dye solution was applied onto the sample surface. It was poured into a cylinder 100mm diameter placed in the centre of the sample at the "T joint." Sealant was used at the plank/cylinder interface to avoid leakage.

The underside of the sample was inspected through the clear Perspex to enable detection of any dye penetration through the sample.
