No. 1429919.2

SAMPLE DESCRIPTION:
LVT flooring samples glued down to Perspex base using
UZIN KE 68 T adhesive.
Range – Ultimo II
Colour – Summer Oak 24219

ISO 4760:2022(E) - LAMINATE FLOORING – TOPICAL MOISTURE RESISTANCE – ASSEMBLED JOINT (MODIFIED)

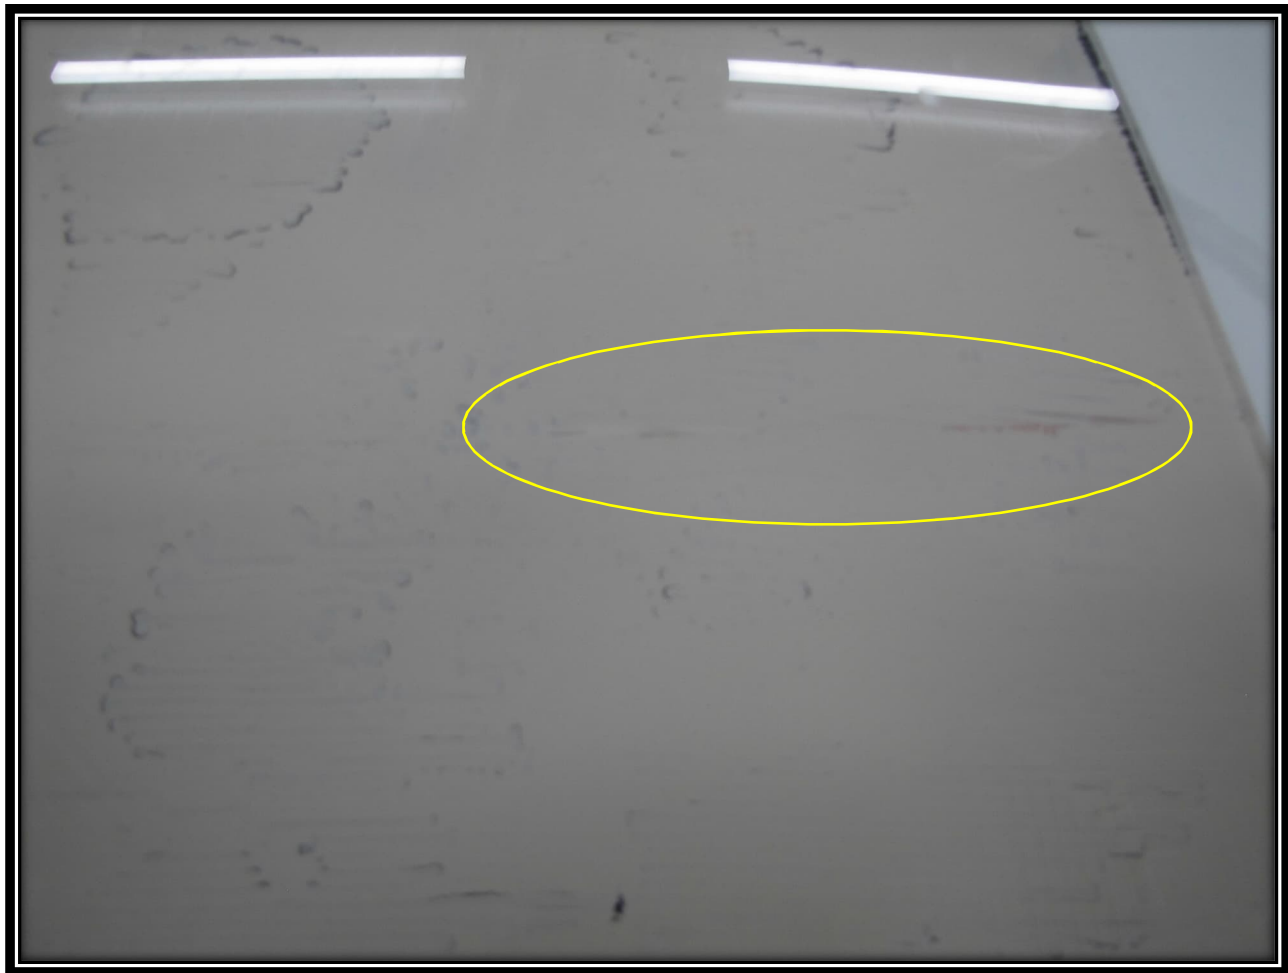
Water penetrated to the Perspex base along the joints.

Wet Swell		
	Specimen 1	Specimen 2	Specimen 3
Observations:	No evidence of water penetrating the underside of the flooring planks through the joints.	No evidence of water penetrating the underside of the flooring planks through the joints.	Water was able to channel through the joints and puddle on the surface of the planks. There was water left inside the ring. Water penetrated to the Perspex base along the joints.

Recovered Swell		
	Specimen 1	Specimen 2	Specimen 3
Observations:	No evidence of water penetrating the underside of the flooring planks through the joints.	No evidence of water penetrating the underside of the flooring planks through the joints.	Water penetrated to the Perspex base along the joints.
