BRANZ Type Test

FI 6025 ISSUE 2

AS ISO 9705 & ISO 9705 FIRE TEST AND NCC SPECIFICATION C1.10 AND
NZBC VERIFICATION METHOD C/VM2 APPENDIX A PERFORMANCE OF
ACOUSTIPIN 10MM

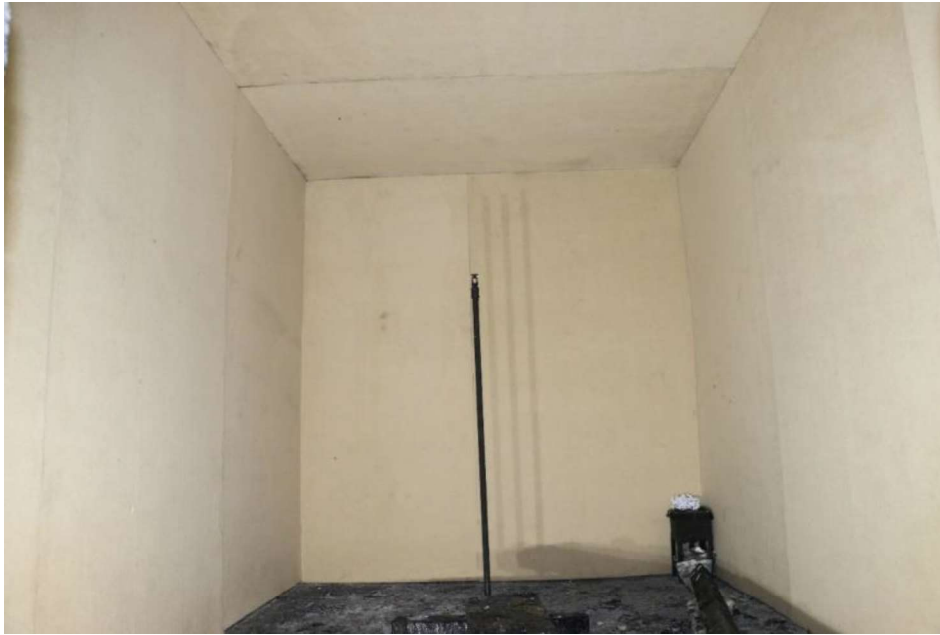
Figure 1: Completed installation

Adhesive fixed with spray adhesive to fibre cement board. Figure 1 shows a detail of the installed product.

A lightweight steel stud frame was installed against the three full walls and ceiling of the test room and lined on the interior face with the nominally 6 mm fibre cement board screwed to the steel frame.

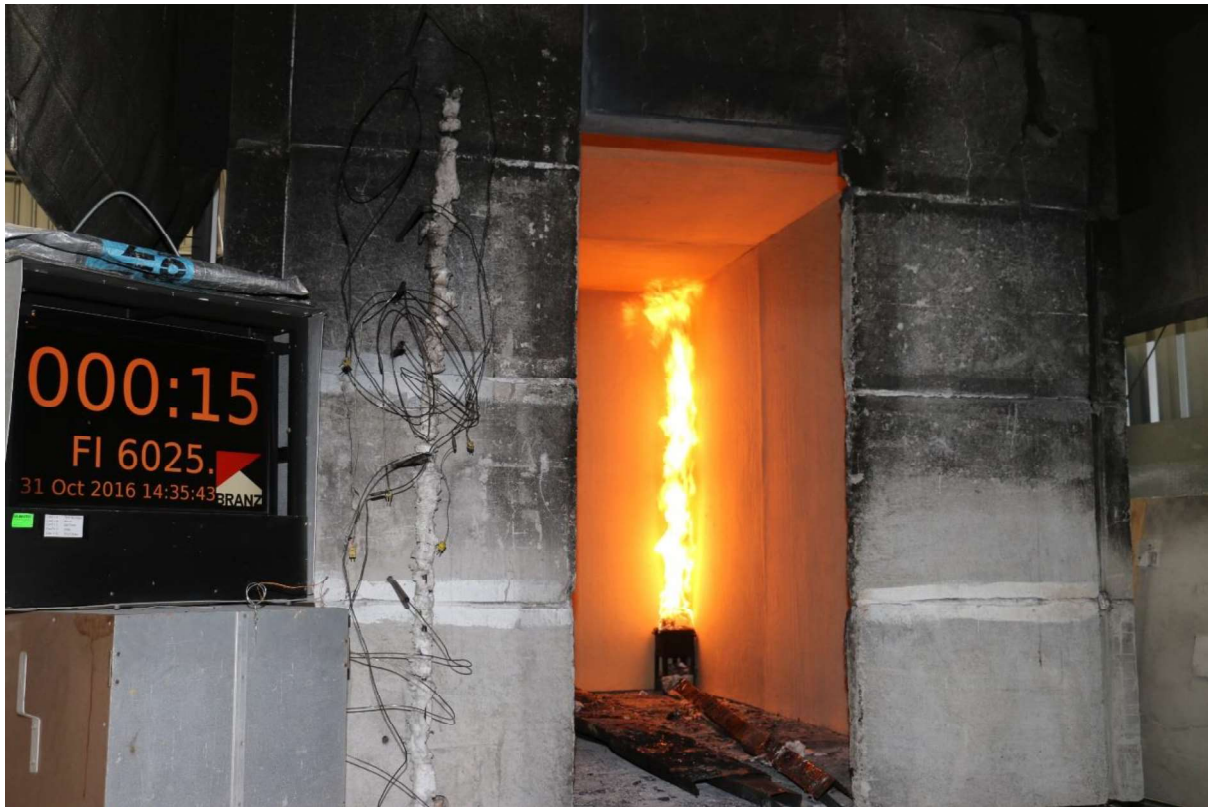
Photograph 3: At 15 seconds.

Time Min:sec	Description
00:15	Burner plume was at the ceiling.
00:30	Small flaming droplets of the test specimen were falling from the ceiling and were extinguishing before landing on floor.

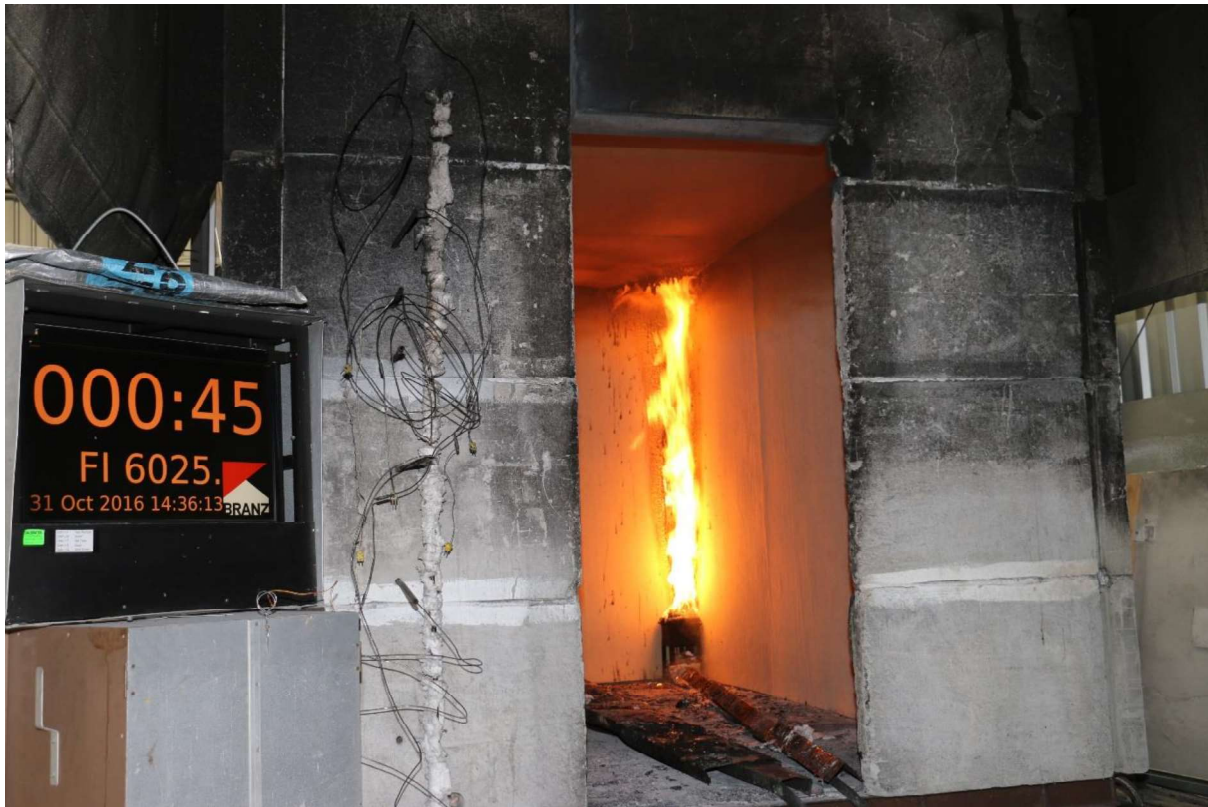
Photograph 5: At 45 seconds

00:45	The burner plume had melted a hole through the Acoustipin on the ceiling approximately 250 mm across and droplets were running down the walls.
1:30	The hole in the ceiling had increased in size to a quarter circle with a radius of 300 mm from the corner. A vertical channel had formed in the corner about 200 mm wide each side of the corner. Black molten droplets were falling down but not igniting.

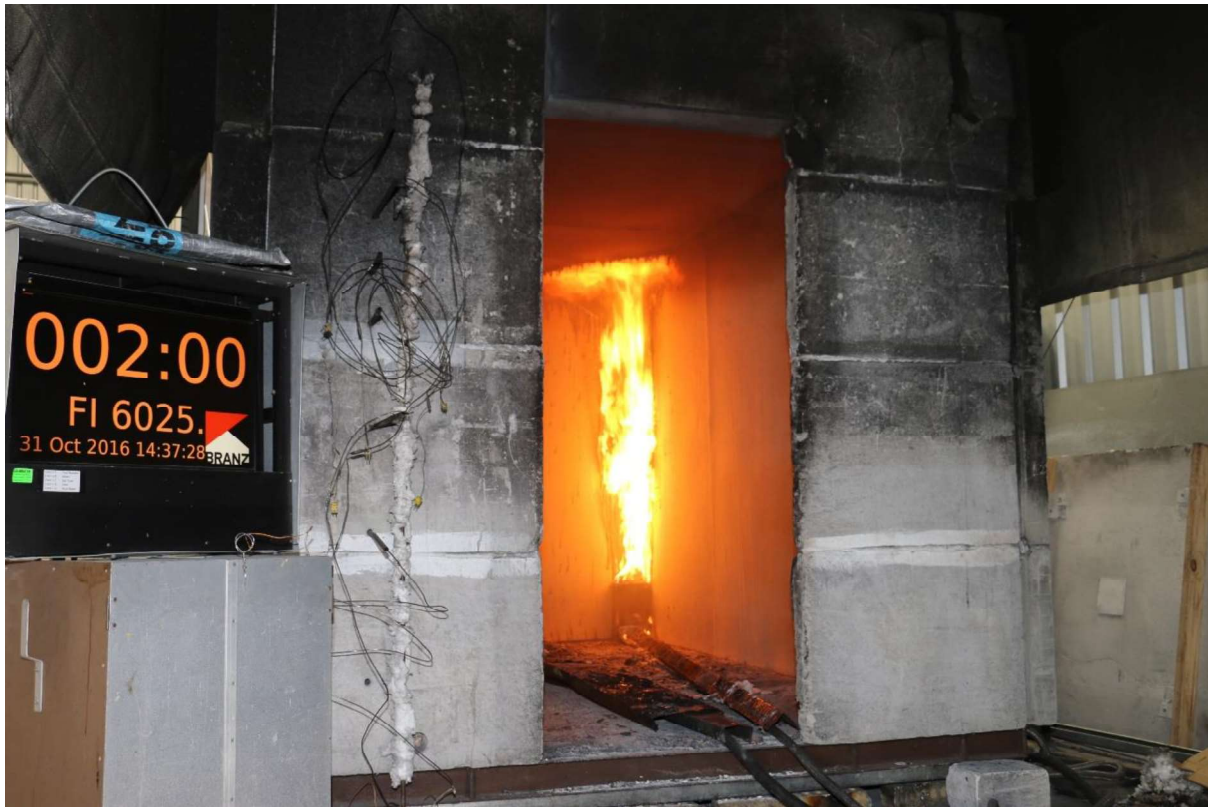
Photograph 7: At 120 seconds

2:00	The hole in the ceiling had increased in size to a quarter circle with a radius of 600 mm from the corner accompanied by intense flaming on the perimeter. Some flaming had also developed on the walls on the boundary of the burner plume.

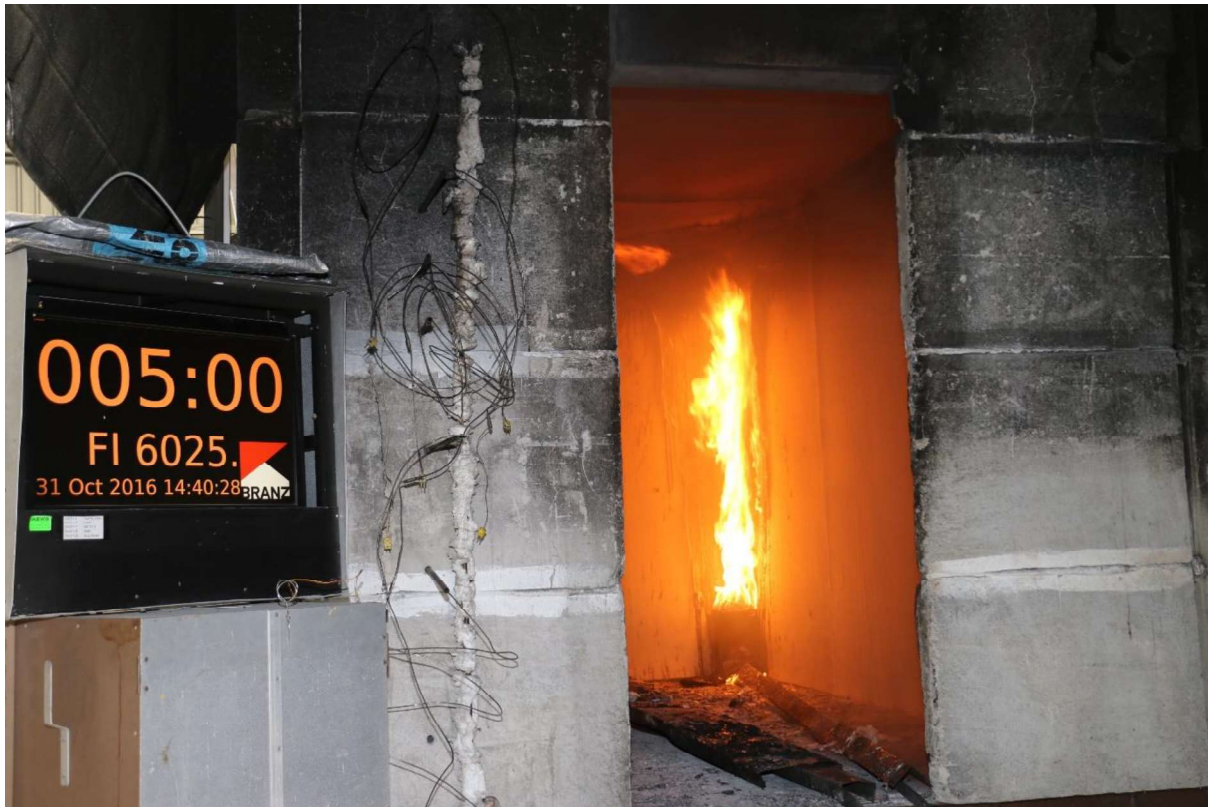
Photograph 9: At 300 seconds

5:00	A small amount of flaming on the Acoustipin continued on the walls in the vicinity of the burner plume about 300 mm from the corner. Isolated pockets of burning material continued at the base of the burner.

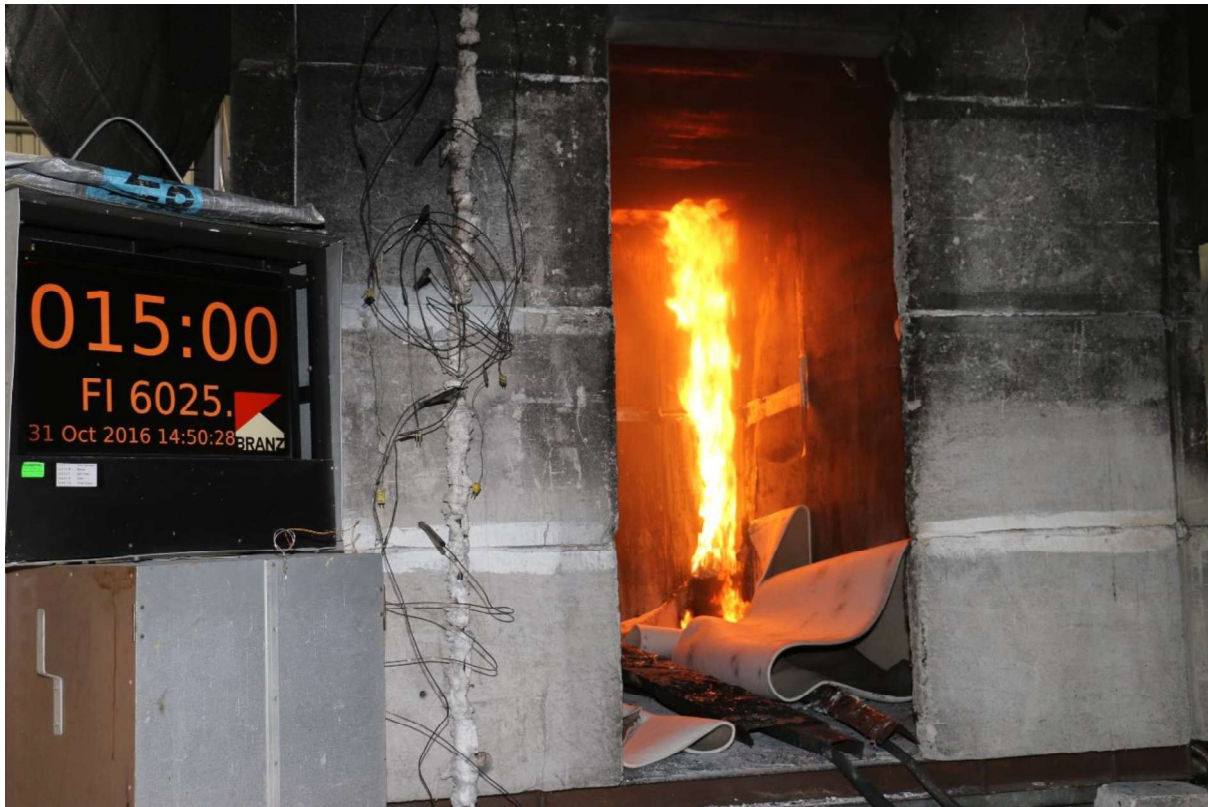
Photograph 19: At 900 seconds

12:00	The Acoustipin on the right hand wall was peeling off and had dropped 1,500 mm above the floor.
15:00	All the Acoustipin had peeled off the walls and was below the hot layer zone in the room. A small fire on the floor in the vicinity of the burner had established.
