# TEST CERTIFICATE No.: INZ84900-02

| Client: | Belgotex NZ |
| Sample Description: | Finfloor XL 10mm |

**Test:** Qualitative rating of laminate flooring

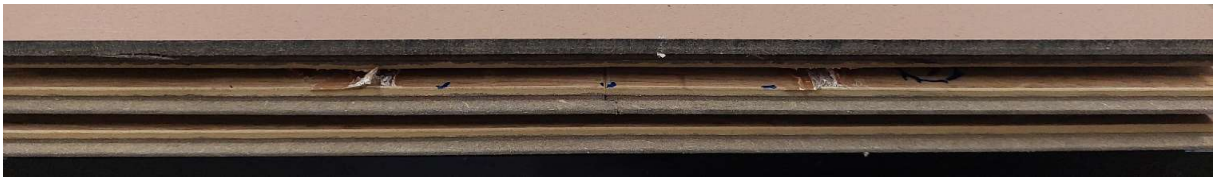
Figure 3 - Photo of sample 2 after disassembly

**Observations:** After disassembling the test area, no water leakage observed through the joints in all samples 1, 2 and 3.
