No. 1524867.7

BJELIN hardened timber planks assembly with PVA

RESILIENT FLOOR COVERINGS (BASED ON ISO 4760:2022(E) - LAMINATE FLOORING - TOPICAL MOISTURE RESISTANCE - ASSEMBLED JOINT (MODIFIED))

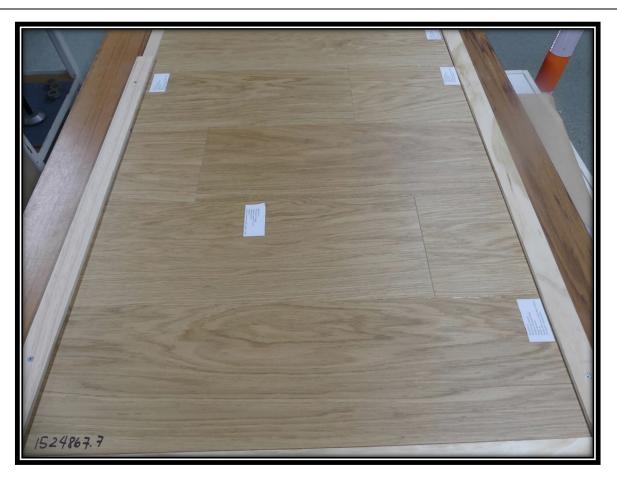
Join system - Valinge 5G Dry

The sample was cut into pieces then connected using the profiled locking edges and fastened into an assembled floating "T joint" configuration as per the test method. The testing was performed in triplicate.

100 mls of dye solution was applied onto the sample surface. It was poured into a cylinder 100mm diameter placed in the centre of the sample at the "T joint." Sealant was used at the plank/cylinder interface to avoid leakage.

The sample was placed on white paper towels prior to testing to enable detection of any dye penetration through the joints. The sample was left at 20°C, 65% Relative Humidity room conditions for 24 hours after the dye was added and then examined for dye penetration through the backing (not 23°C, 50% RH as stated in the method).
