No. 1524859.4

CLIENT: Belgotex 25 Leslie Hills Drive	SAMPLE RECEIVED FROM: Belgotex	Date Received:	23.7.24
Riccarton, Christchurch	SAMPLE DESCRIPTION: BOEN engineered timber planks (Live Natural – o	oil	
Attn.: Geri Hansen	finish) assembly adhered to a clear Perspex usin Mapei Ultrabond-eco-s995-1k. Dimension – 2200x181x13.2mm Range – Plank 181 & Castle Plank 209 Model – Plank 181 Join System – Valinge 5G		
Client Order No.:	Client Reference:		1 of 4

RESILIENT FLOOR COVERINGS (BASED ON ISO 4760:2022(E) - LAMINATE FLOORING – TOPICAL MOISTURE RESISTANCE - ASSEMBLED JOINT (MODIFIED))

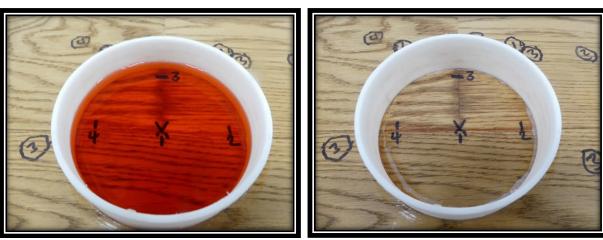
After 24 hrs With Water

Recovered Swell

Recovered Swell (Disassembled)

The sample was cut into pieces then connected using the profiled locking edges and fastened into an assembled "T joint" configuration as per the test method. The assembled planks were adhered to a clear Perspex. The testing was performed in triplicate. Weights were not used on these samples.

100 mls of dye solution was applied onto the sample surface. It was poured into a cylinder 100mm diameter placed in the centre of the sample at the "T joint." Sealant was used at the plank/cylinder interface to avoid leakage.

The sample was placed on white paper towels prior to testing to enable detection of any dye penetration through the joints. The sample was left at 20°C, 65% Relative Humidity room conditions for 24 hours after the dye was added and then examined for dye

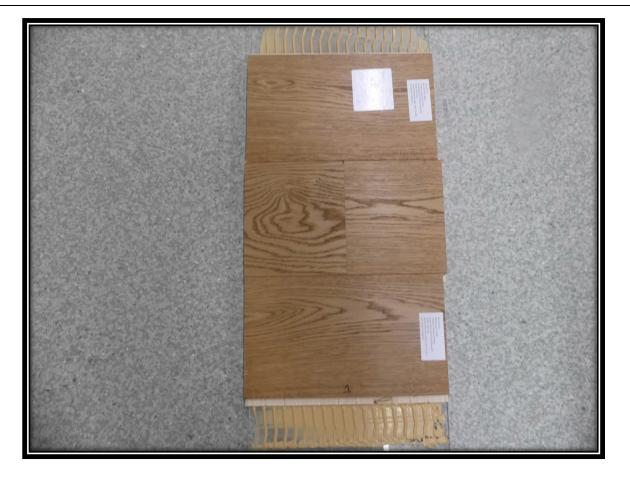
SAMPLE DESCRIPTION: BOEN engineered timber planks (Live Natural – oil finish) assembly adhered to a clear Perspex using Mapei Ultrabond-eco-s995-1k. Dimension – 2200x181x13.2mm Range – Plank 181 & Castle Plank 209 Model – Plank 181 Join System – Valinge 5G
