**No. 1566377.6**

SAMPLE DESCRIPTION:  
Parky Pro Enhanced assembly flooring  
7.2mm Harden timber.

**ISO 4760:2022(E) - LAMINATE FLOORING – TOPICAL MOISTURE RESISTANCE – ASSEMBLED JOINT (MODIFIED)**

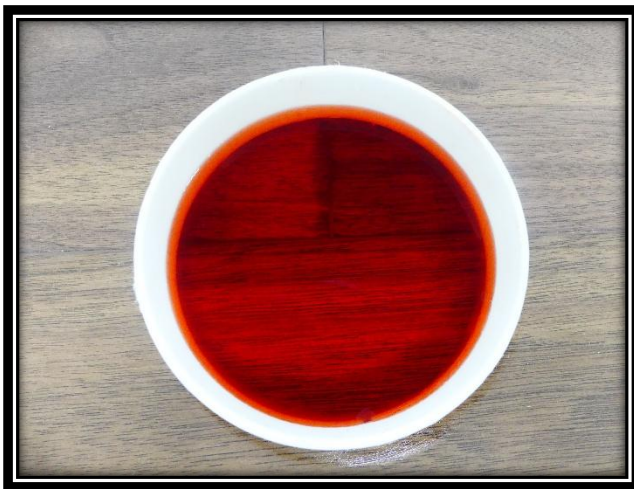
After 24 hrs With Water

100 mls of dye solution was applied onto the sample surface. It was poured into a cylinder 100mm diameter placed in the centre of the sample at the "T joint." Sealant was used at the plank/cylinder interface to avoid leakage.

The sample was placed on white paper towels prior to testing to enable detection of any dye penetration through the joints.

The sample was left at 20°C, 65% Relative Humidity room conditions for 24 hours after the dye was added and then examined for dye penetration through the backing (not 23°C, 50% RH as stated in the method).

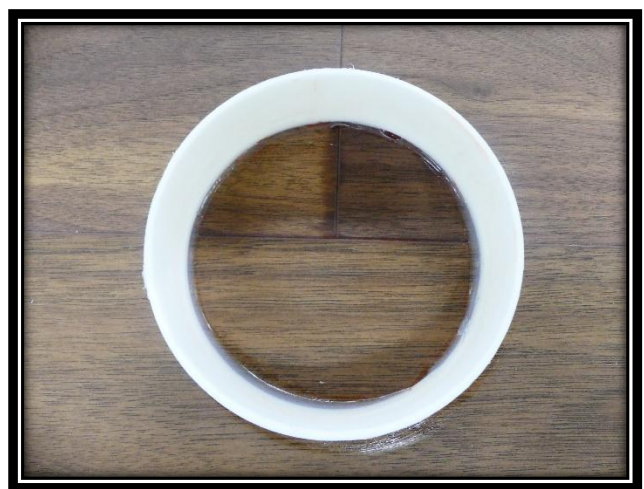
Wet Swell

Quantitative measurements are used to calculate surface swell in mm (within 15 minutes after water removal) and recovery swell (24 hours after removal of water).

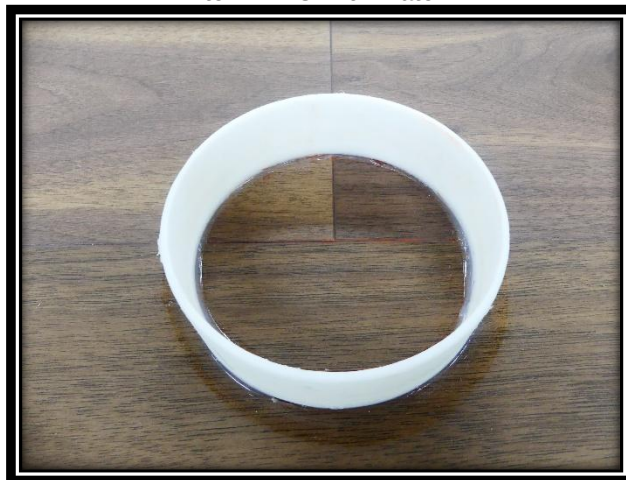
Recovered Swell

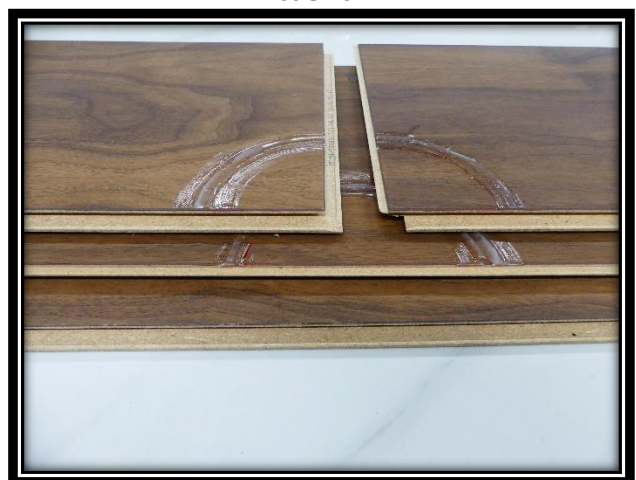
Recovered Swell (Disassembled)
