No. 1428489.7R

SAMPLE DESCRIPTION:
Laminate Flooring – Solido Elite WR (832-4)
Nominal Size – 192mm x 1285mm
Nominal Wearlayer Thickness – 0.1mm
Locking System – Megaloc Aqua Protect

ISO 4760:2022(E) - LAMINATE FLOORING – TOPICAL MOISTURE RESISTANCE – ASSEMBLED JOINT (MODIFIED)

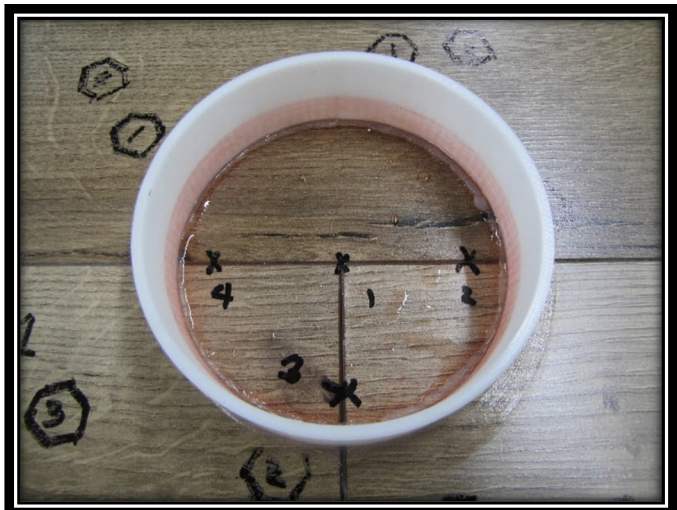
Wet Swell		
	Specimen 1	Specimen 2	Specimen 3
Observations:	No penetration through the joints.	No water penetration through the joints.	No water penetration through the joints.

Quantitative Results:	Wet Swell (mm)			Recovered Swell (mm)		
	Specimen 1	Specimen 2	Specimen 3	Specimen 1	Specimen 2	Specimen 3
Final Average (Positions 2 to 4)	0.00	0.00	0.00	0.00	0.00	0.00
Final average (Position 1)	0.00	0.00	0.00	0.00	0.00	0.00
